## 4.0 Georgia Avenue and Kennedy Street NW

The May 26, 2016 site visit included Councilmember Cheh’s staff, Councilmember Todd and staff, bicycle and pedestrian safety advocates, MOCRS staff, DDOT staff, and a representative from the DC Pedestrian Advisory Council.

### Spring 2016 High Crash Intersection Site Visits

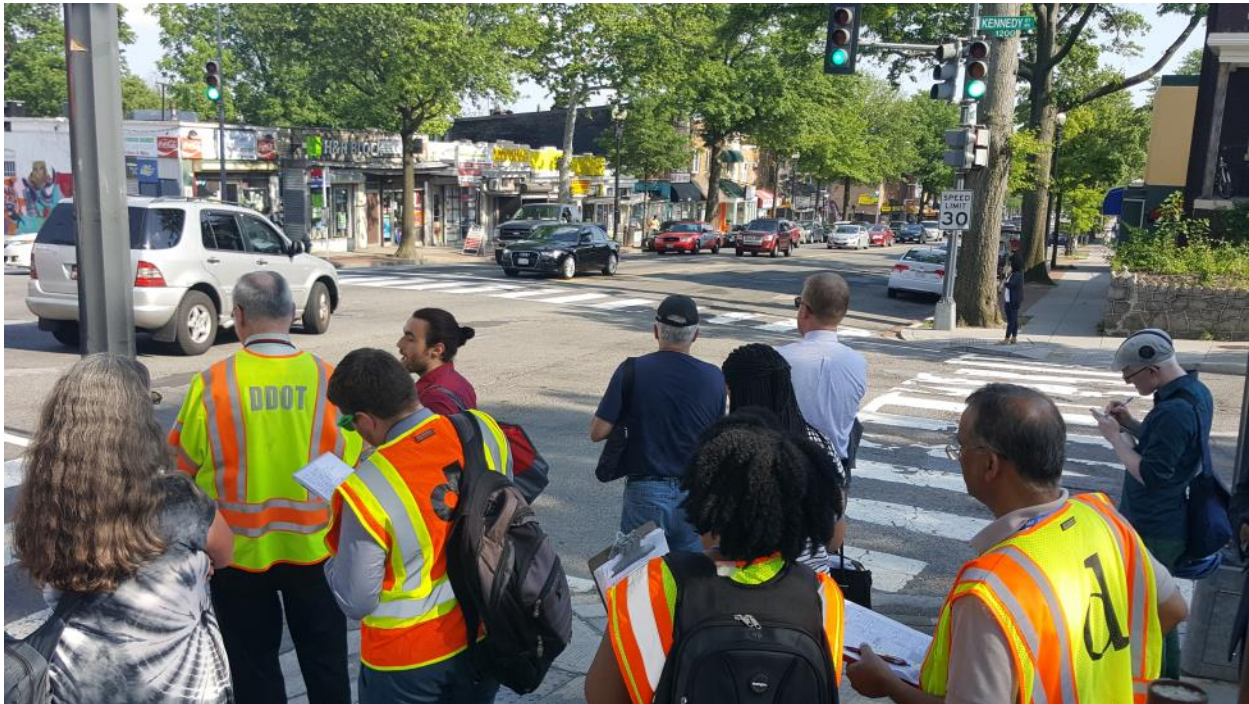
Figure 12. Georgia Avenue and Kennedy Street NW Site Visit

The intersection of Georgia Avenue and Kennedy Street NW is located in Ward 4. There is no nearby Metro station, but it is a major bus transfer point. The intersection is served by the 70/79 routes that travel on Georgia Avenue, and the E4 route that travels on Kennedy Street. At the study intersection, Georgia Avenue is a north-south roadway, with two-way traffic; Kennedy Street is an east-west roadway, with two-way traffic. Georgia Avenue is classified as a principal arterial with a posted speed limit of 30 mph. Kennedy Street is classified as a collector with a posted speed limit of 25 mph. The average ADT is 21,000 along Georgia Avenue and 7,100 along Kennedy Street.

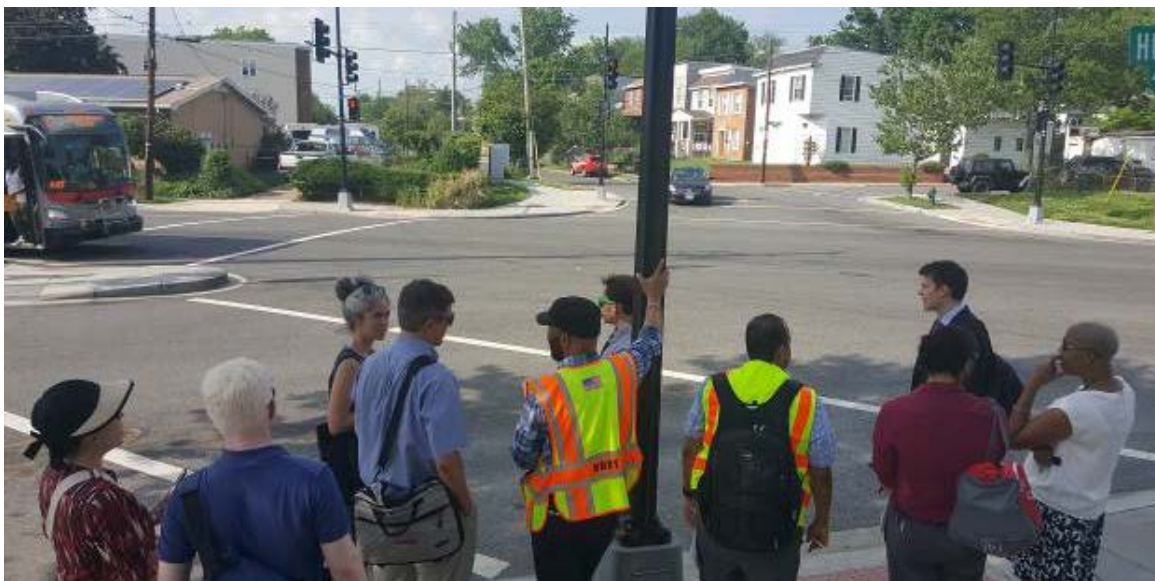
Figure 16. 44th Street and Nannie Helen Burroughs Avenue NE Site Visit

The intersection of 44th Street and Nannie Helen Burroughs Avenue NE is located in Ward 7. The intersection is signalized with five approaches, including Hunt Place. This segment of 44th Street is classified as a collector, while Nannie Helen Burroughs Avenue is classified as a minor arterial street. The traffic signal operates in a pre-timed mode with a cycle length of 80 seconds during the AM peak hour, 75 seconds during the PM peak hours, and 75 seconds during off-peak hours. The posted speed limit on Nannie Helen Burroughs Avenue is 30 mph, while the unposted speed limit on 44th Street and Hunt Place are 25 mph. No parking restriction signs are posted along west curb of 44th Street between Hunt Place and Nannie Helen Burroughs Avenue.

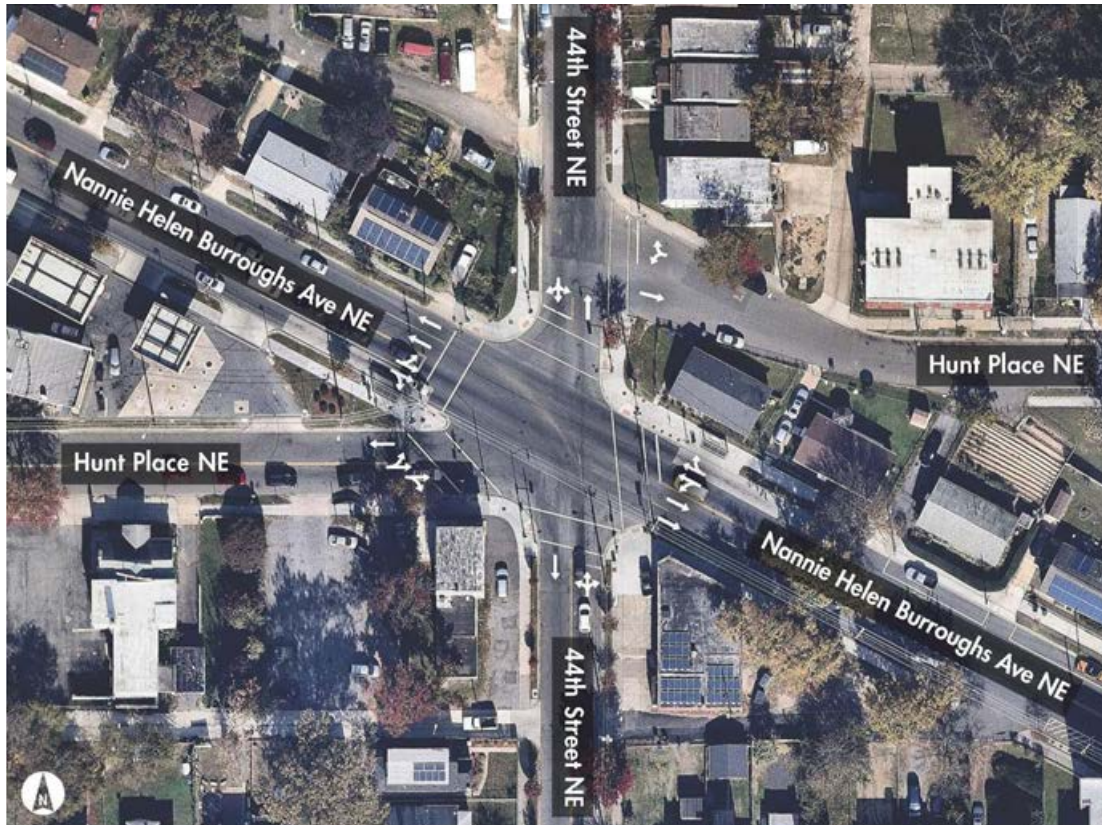
Figure 19. 44th Street and Nannie Helen Burroughs Avenue NE Intersection Diagram

Participants identified issues related to improving driver behavior. Observations conducted during the site visit found that many drivers travel along Nannie Helen Burroughs Avenue in excess of the 30 mph posted speed limit. This can contribute to crash occurrences and increase crash severity. Some such issues may only require minor fixes, while others could require more substantial capital improvements. Many require further investigation and evaluation by DDOT.

- P1. Evaluate signal phasing and pedestrian signals.
- P2. Refurbish crosswalk markings.
- P3. Possible curb extension on Hunt Place.

- T1. Explore relocating eastbound bus stop.

- V1. Motorists observed turning too wide.
- V2. Evaluate lane drop on eastbound Nannie Helen Burroughs Avenue.

Issue	Next Step	Timeline
<b>Pedestrian Issues</b>		
P1. Evaluate signal phasing and pedestrian signals across Hunt Place.	Pedestrians crossing Hunt Place currently run concurrent with 44th, although there are some heavy turn volumes. Determine if LPI would be feasible for pedestrians crossing Hunt and eastbound leg of NHB.	Evaluation: Fall 2016 Implementation: The evaluation determined that the current configuration is optimal.
P2. Crosswalk markings on NHB are not visible enough	Upgrade crosswalk markings on NHB to high visibility.	Evaluation: February 2017 Implementation: Two high visibility crosswalks will be installed by spring 2017, weather permitting.
P3. Curb extension on Hunt Place.	Potential to shorten Hunt Place crossing with curb extension on SW corner of intersection.	Evaluation: Winter 2017 Implementation: Evaluate implementing implications, with implementation in Spring 2017.

<b>Transit Issues</b>		
T1. Explore relocating eastbound bus stop to far side of 44th Street	To be discussed with WMATA	Evaluation: Winter 2017 Implementation: Coordinate with WMATA for implementation in Spring 2017.
<b>Vehicular Issues</b>		
V1. Motorists observed turning too wide.	Puppy skips to guide NB 44th Street motorists onto WB Nannie Helen Burroughs Ave	Evaluation: February 2017 Implementation: Further evaluation determined that puppy skips are not warranted at this intersection.
V2. Evaluate lane drop on EB NHB.	Contingent on T1. With relocation of bus stop to far side, lane drop could happen at 44th.	Evaluation: Winter 2017 Implementation: Contingent upon evaluation of T1.

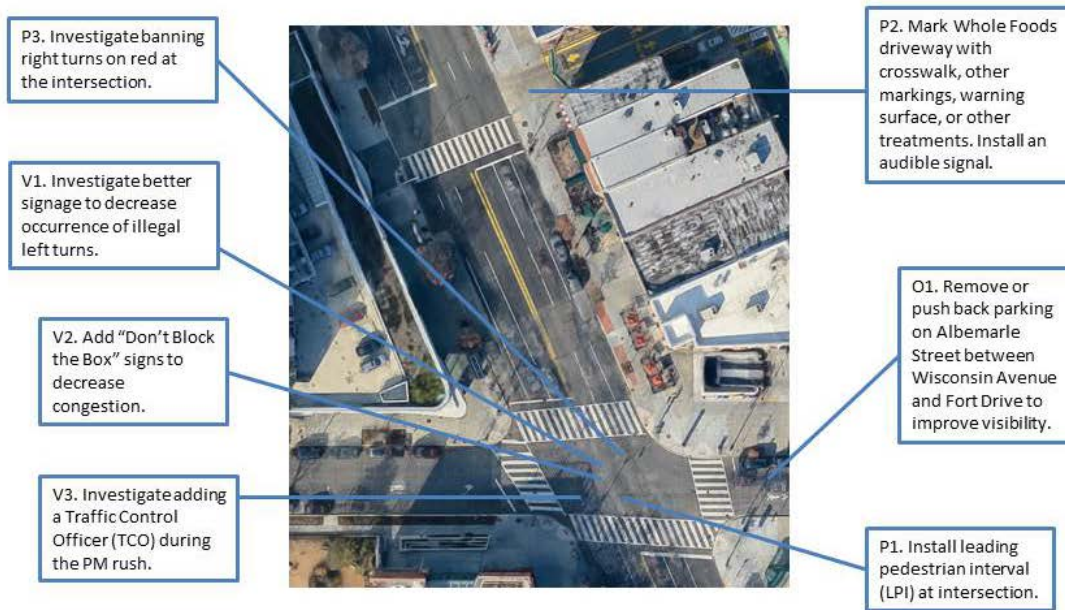
Figure 25. Wisconsin Avenue and Albemarle Street NW Site Visit Observations

On Wednesday, August 17, 2016 beginning at 8:30am, participants identified issues related to all travel modes. Some may only require minor fixes, while others may require more substantial capital improvements. Many require further investigation and evaluation by DDOT. The timeline for next steps is included in the next section.

Issue	Next Step	Timeframe
P3. Drivers making right turns on red present challenges for pedestrians.	Investigate banning right turns on red at the intersection.	Evaluation: Winter 2017 Implementation: Line of sight analysis to be performed within 120 days.
<b>Vehicular Issues</b>		
V1. Left turns from SB Wisconsin to Albemarle are banned during rush hour but drivers still make illegal turns.	Investigate better signage to decrease occurrence of illegal left turns.	Evaluation: Winter 2017 Implementation: Shop order submitted February 2017 for replacement "No left turn" signs.
V2. Drivers blocking the box.	Add "Don't Block the Box" signs to decrease congestion.	Evaluation: Winter 2017 Implementation: Shop orders submitted February 2017 for signs at Wisconsin Ave northbound and southbound approaches.
V3. Need TCO during PM rush.	Investigate stationing a TCO during PM rush.	Evaluation: Winter 2017 Implementation: Analysis underway, with recommendation by March 2017.

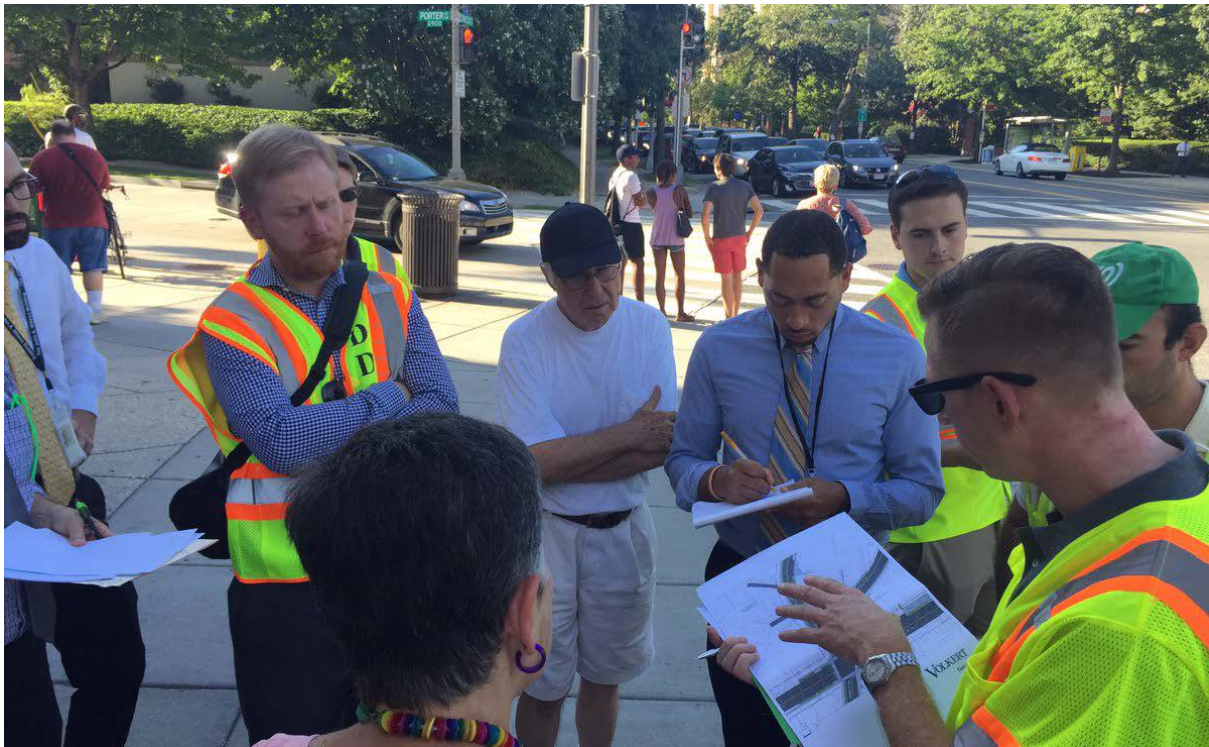
Figure 26. Connecticut Avenue and Porter Street NW Site Visit

The intersection of Connecticut Avenue and Porter Street NW is located adjacent to the Cleveland Park Metro station. At the study intersection, Connecticut Avenue is a six-lane north-south roadway with two-way traffic; Porter Street is a four-lane east-west roadway with two-way traffic. To the east of the intersection, Quebec Street NW intersects Porter Street on the north side of the roadway, with a slip lane to Connecticut Avenue for northbound traffic.

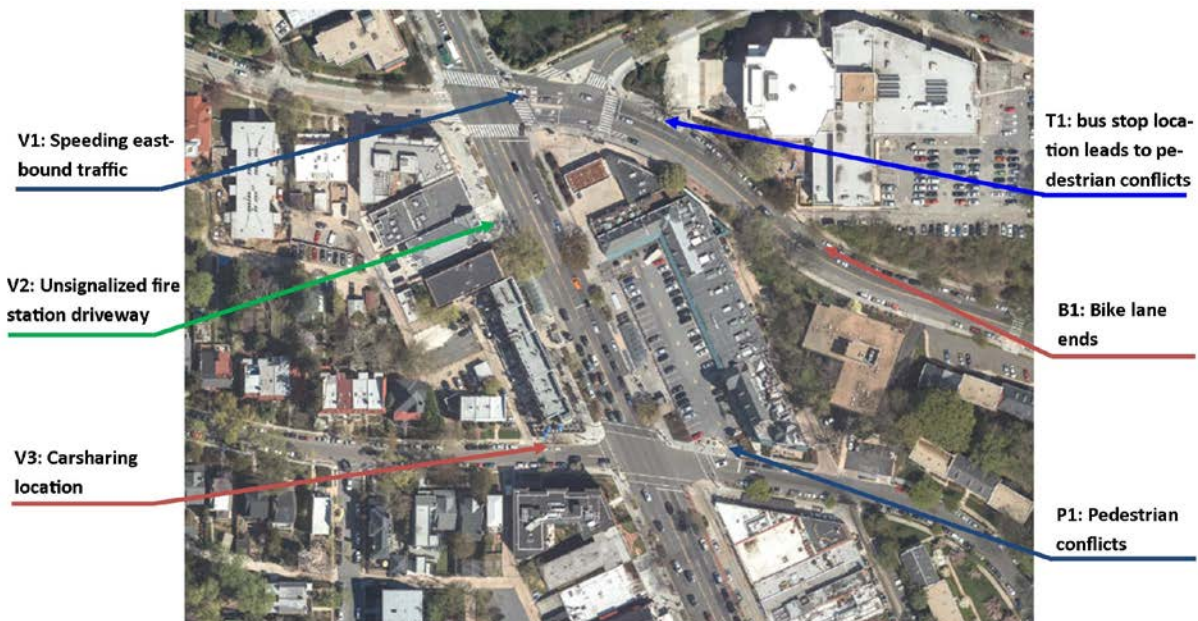
Figure 28. Connecticut Avenue and Porter Street NW Site Visit Observations

On Wednesday, August 17, 2016 at 5:30 pm, participants identified issues related to all travel modes. Some may only require minor fixes, while others may require more substantial capital improvements. Many require further investigation and evaluation by DDOT. The timeline for next steps is included in the next section.

Issue	Next Step	Timeframe
<b>Vehicular Issues</b>		
V1. Eastbound traffic from Porter Street speeds through 30th Street and adjacent alleys due to queuing on approach to intersection with Connecticut Avenue.	Recommended installation of new off-set double yellow centerline and whiteline to create a left turn lane for northbound traffic from Porter. Crosswalk and stopbar pavement markings to be refurbished, as well as new sign installation.	Evaluation: November 2016 Implementation: Markings and sign installation completed November 2016.
V2. Fire station driveway on Connecticut Avenue is unsignalized.	Conduct signal warrant analysis for fire station driveway.	Evaluation: Winter 2017 Implementation: To be included in Cleveland Park Streetscape and Drainage Improvement Project, with completion by end of 2018.
V3. Carsharing location on the west side of Connecticut Avenue and Ordway Street conflicts with southbound vehicles turning right from Connecticut onto Ordway Street.	Eliminate one Enterprise parking location, and relocate the other to the east side of Connecticut Avenue and Ordway Street.	Evaluation: Complete Implementation: February 15, 2017

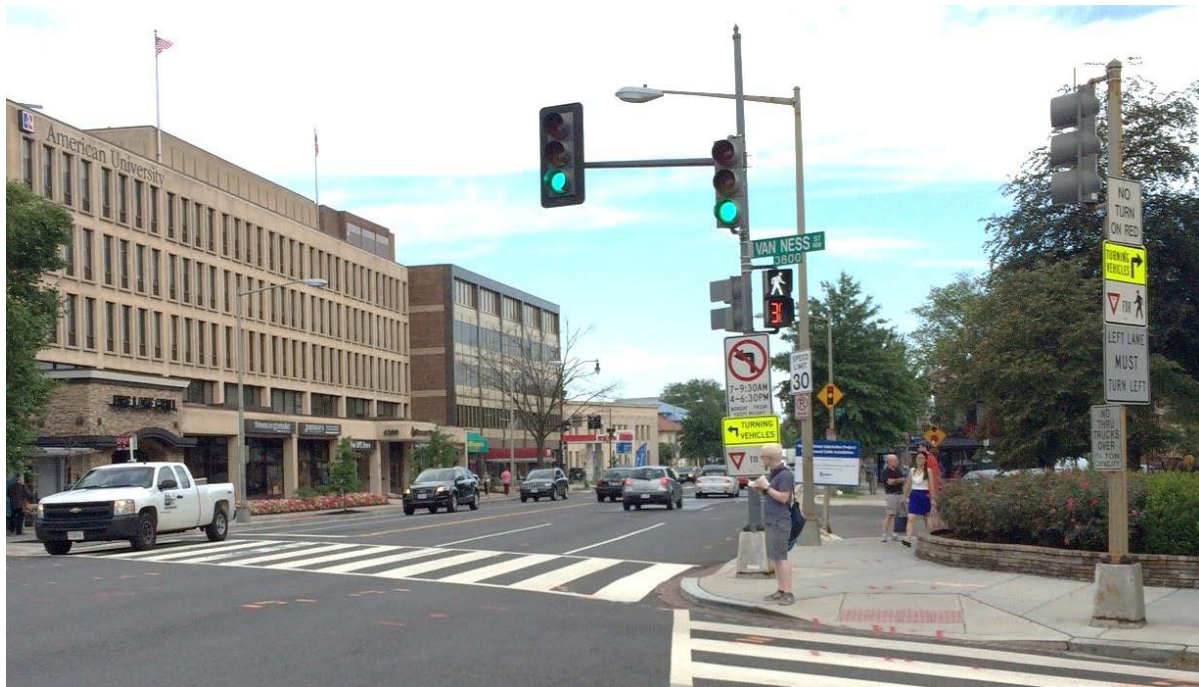
Figure 29. Wisconsin Avenue, Van Ness Street, and 39th Street NW Site Visit

The intersection of Wisconsin Avenue, Van Ness Street, and 39th Street NW is approximately half a mile south of the Tenleytown-AU Metro station. At the study intersection, Wisconsin Avenue is a six-lane north-south roadway with two-way traffic and street parking during off-peak periods; Van Ness Street is a three-lane east-west roadway with two-way traffic. Just north of Van Ness Street, Wisconsin Avenue intersects with 39<sup>th</sup> Street NW, a one-way northbound street with two lanes of street parking and one travel lane.

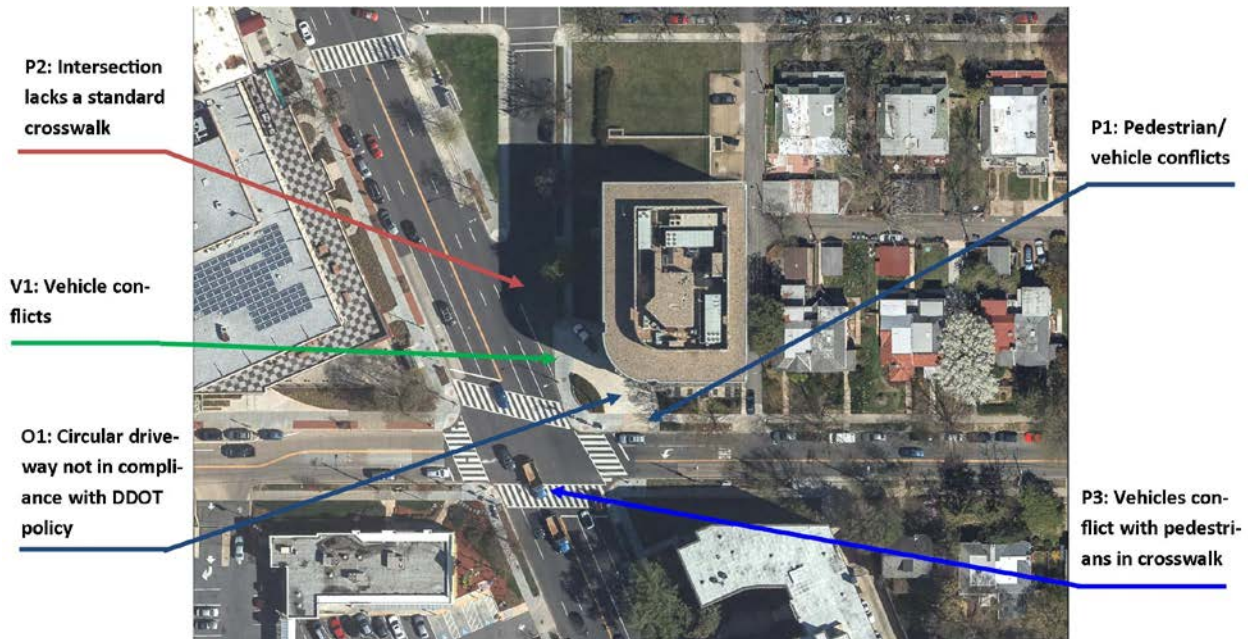
Figure 31. Wisconsin Avenue, Van Ness Street, and 39th Street NW Site Visit Observations

On Wednesday, August 18, 2016 beginning at 8:30am, participants identified issues related to all travel modes. Some may only require minor fixes, while others may require more substantial capital improvements. Many require further investigation and evaluation by DDOT. The timeline for next steps is included in the next section.

P3. Turning vehicles were observed conflicting with pedestrians legally in the crosswalk for the intersection of Van Ness Street and Wisconsin Avenue.

V1. Vehicles entering and exiting the driveway present conflict hazards to vehicles on Van Ness Street and 39<sup>th</sup> Street.

Issue	Next Step	Timeframe
P2. The intersection of 39th Street at Wisconsin Avenue lacks a standard crosswalk. This is complicated by the circular driveway curb cut on 39th Street.	A permanent curb extension to reduce pedestrian conflicts on 39 <sup>th</sup> St should be designed and constructed, along with a standard crosswalk.	Evaluation: Fall 2016 Implementation: Contingent upon driveway and curb cut removal timeframe.
P3. Turning vehicles were observed conflicting with pedestrians legally in the crosswalk for the intersection of Van Ness Street and Wisconsin Avenue.	Leading pedestrian intervals should be added at the intersection of Van Ness St and Wisconsin Ave.	Evaluation: Winter 2017 Implementation: Signals team to analyze and implement by spring 2017.
<b>Vehicular Issues</b>		
V1. Vehicles entering and exiting the driveway present conflict hazards to vehicles on Van Ness Street and 39th Street.	Driveway and curb cuts should be removed.	Evaluation: Fall 2016 Implementation: Contingent upon driveway and curb cut removal timeframe.
